A Comparative Study of Alkoxysilanes and Acrylics in Sequence and in Mixture

Frank G. Matero

Anne B. Oliver

Reprinted from *Journal of Architectural Conservation*, Volume 3, Issue 2, July 1997.

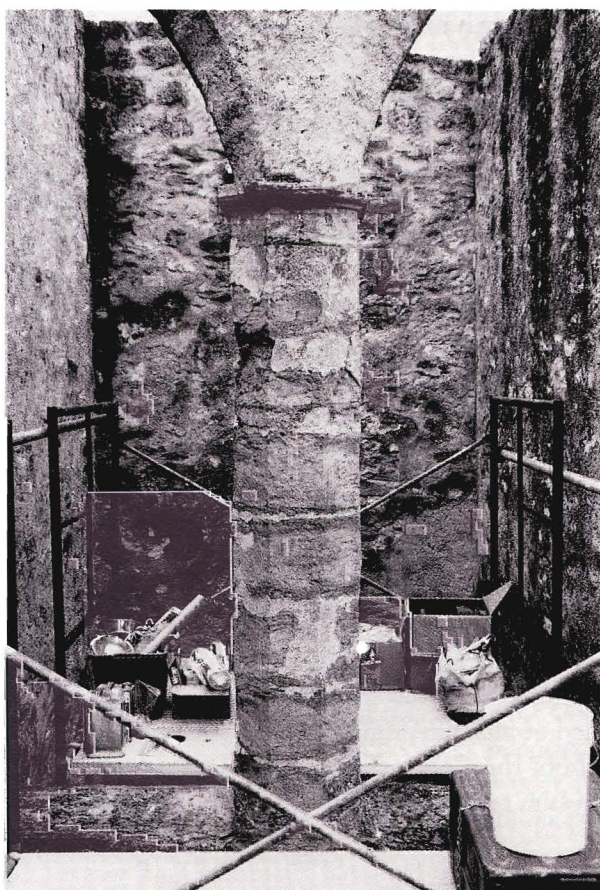
Figure 1
*South elevation of
Convento column
before conserva-
tion (1993).*

The mission complex was again largely abandoned until the 1920s, when renewed interest in all of the San Antonio missions resulted in extensive archaeological investigation, reconstruction and maintenance of the structures. In conjunction with these efforts, the Convento of Mission San José was stabilized and the column bears the evidence of two repair campaigns. The first is revealed in a photograph from around 1927 in which large white patches are visible; these matched the locations of present-day gypsum repairs. The second set of repairs were applied at an undetermined later date, and appear in photographs dating from the 1960s; these are of lime and sand, and overlay the earlier gypsum repairs and original gypsum bedding mortar (Figure 1).

The condition of the column prior to conservation was quite poor. Levels of deterioration were localized, such that sound surfaces were interspersed with deteriorated surfaces. The southern faces of the column were relatively sound, as were isolated areas on other faces. No gypsum was used on or above the capital of the column and this drum was in excellent condition. Sound surfaces did not require any consolidative treatments, but would benefit from the application of a water repellent.

The most severe deterioration was located in areas immediately beneath and adjacent to gypsum mortar and repairs; stone in these areas was very friable to the touch and exhibited the extensive micro-cracking and flaking typical of salt-contaminated stone. Many repairs of lime and gypsum rang hollow when tapped, indicating poor attachment to the underlying stone. When these repairs were subsequently removed, the stone beneath was found to be severely deteriorated (Figure 2). The deteriorated areas displayed excessive friability (loss of intergranular cohesion) to a depth of up to 5 cm, as well as flaking (delamination) of larger fragments of stone. These two types of deterioration required two types of treatment: a deeply-penetrating consolidant to re-establish intergranular cohesion, and an adhesive to restore cohesion between larger grains and to bridge the gaps between large flakes caused by microcracking.

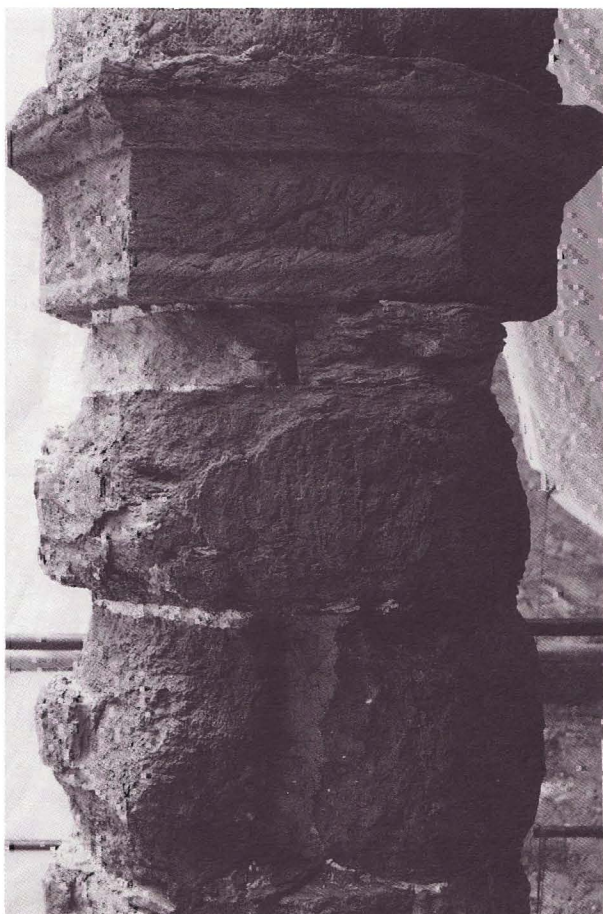
Figure 2
Top of east
elevation of
Convento column
after removal of old
repairs and before
conservation
(1993).

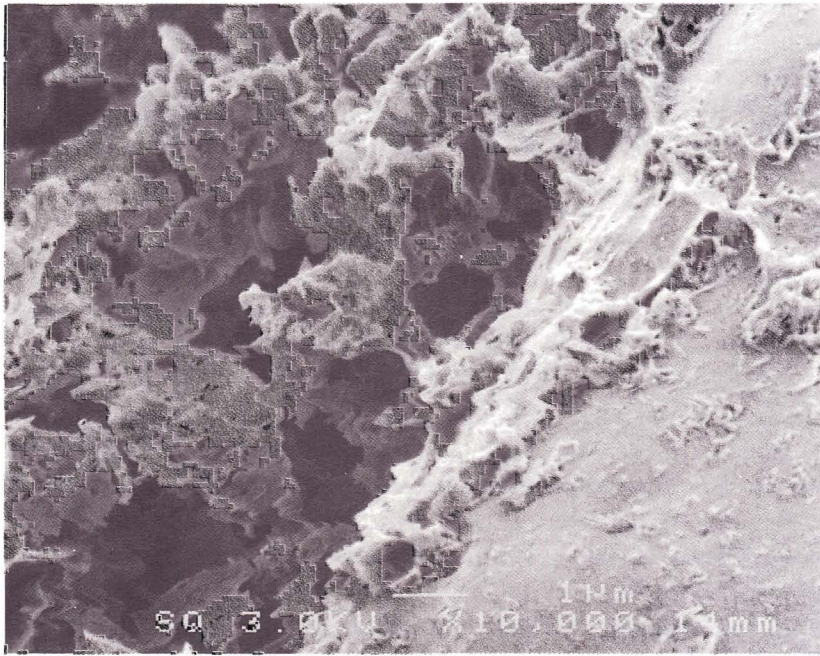
Figure 3 SEM photomicrograph of model treated with ES followed by sequential applications of EM/MA and MTMOS (SQ) and etched with 1M HCl (3.0KV, 10,000X magnification). In appearance, the microstructure of SQ is almost identical to the ES visual reference; it forms a glassy and discontinuous film. The presence of EM/MA and MTMOS is difficult to discern. The SQ appears less flat and more flexible than ES. Voids indicate the location of calcite grains prior to etching; few calcite grains are visible after etching.

should have had any effect on the inorganic SiO_2 matrix formed by the cured ES. Results are in the form of photomicrographs; only the SQ and MX results are reported here (Figures 3 and 4).

Based upon the observed quantity of material deposited on the models, treatments with mixtures of EM/MA and MTMOS could be considered more effective than treatments with sequences of the same. The heterogeneity of the SQ film, and the contrasting homogeneity of the MX film, is a function of quantity, rather than of any visible segregation or irregular deposition of the two materials. Wheeler *et al*¹² found that when EM/MA and MTMOS were applied in a mixture, the EM/MA 'entrapped' the MTMOS material, preventing its evaporative loss and promoting condensation at later stages of polymerization. From the above images, it would appear that cured EM/MA does not entrap the MTMOS material.

indicate that more EM/MA and MTMOS are deposited on the models than is visible in the SQ photomicrographs. It should be noted that only the surface-layer microstructure of the SQ and MX models was examined, and that the microstructure may be different at greater depths. In addition, only one SQ sample was examined, and the average appearance of SQ treatments cannot be generalized from these images. While the appearance of the MX photomicrographs is consistent with other SEM images of EM/MA/MTMOS mixtures,^{10,16,17} no SEM examinations of sequential applications of EM/MA and MTMOS were found in the literature. Further research is required to fully understand the microstructure of sequential applications.

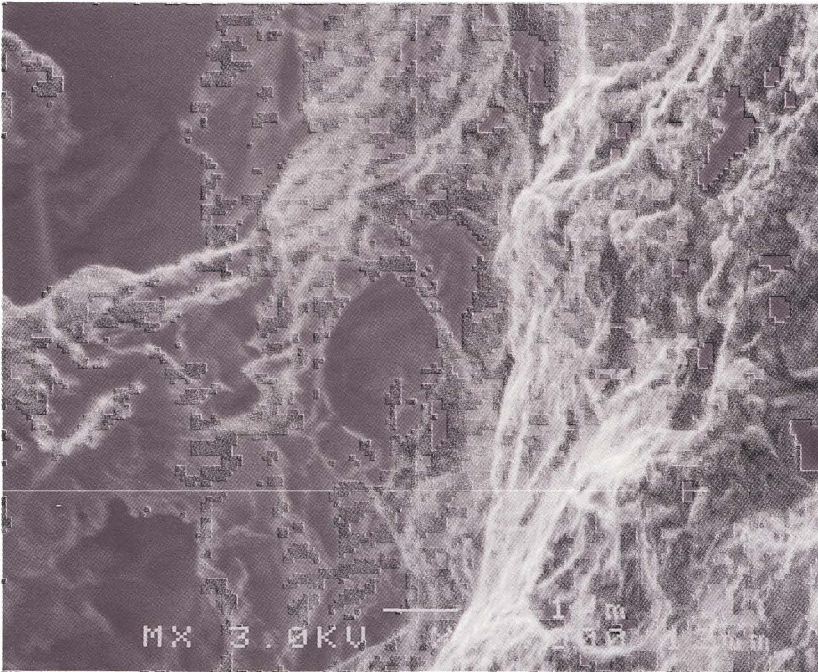
Figure 4 SEM photomicrograph of model treated with ES followed by a mixture of EM/MA and MTMOS (MX) and etched with 1M HCl (3.0KV, 10,000X magnification). In appearance, the microstructure of MX forms a thin and continuous film; the brittle and discontinuous ES pre-treatment is no longer visible and is presumably overlaid by the MX treatment. The smoothness and continuity of the film indicate the uniform dissolution of EM/MA in MTMOS, as does the somewhatropy nature of the film, visible as ridges around voids. Although these voids indicate that calcite grains were lost from the surface during etching, many others are still held within the MX matrix and are also visible in the layer immediately beneath the film. This physical 'locking-in' of calcite grains, for which MTMOS and EM/MA have no chemical affinity, was also observed by Charola et al.¹⁵

One major difference in the application of EM/MA and MTMOS in sequence versus mixture is that toluene is used to dissolve the EM/MA in the sequential application, while the methanol intrinsic to the MTMOS is used to dissolve the EM/MA in the mixed application. The vapour pressure of methanol (95 mm Hg at 20°C) is higher than that of toluene (22 mm Hg at 20°C). Although EM/MA entraps MTMOS at later stages of polymerization, the presence of EM/MA in the MTMOS solution has no effect on initial evaporative loss.¹² Methanol, the more volatile solvent, may reduce the dwell time and induce the reverse migration of the EM/MA/MTMOS mixture at initial stages of polymerization, resulting in an accumulation of MX at the surface of the treated object, the presence of which we may be observing in Figure 4.

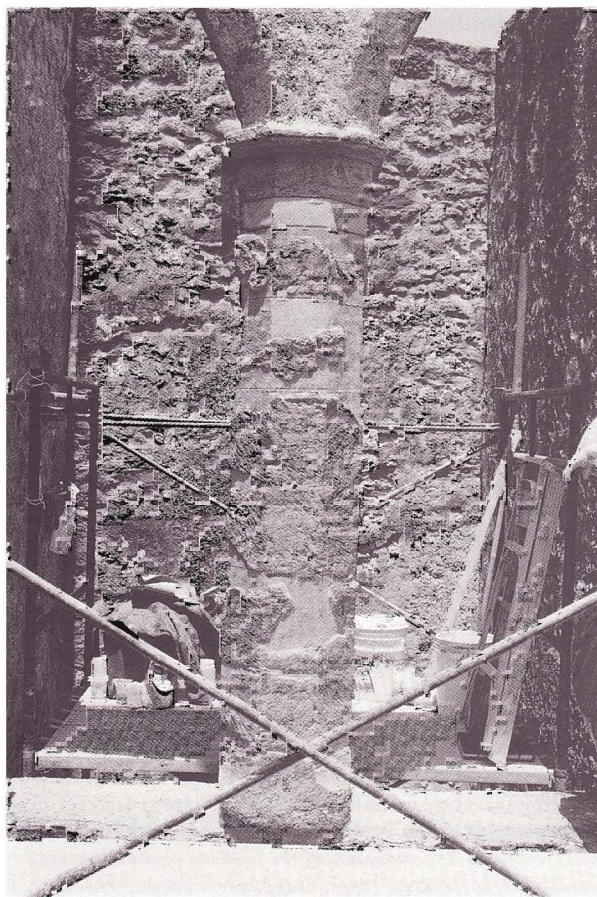
Figure 5
South elevation of
the Convento
column after
completion of all
conservation
treatments (1993).

Since the completion of treatment in 1993 (Figure 5), maintenance inspections of the column have been conducted in 1994 and 1996. The results of RILEM water absorption tests indicate no change in the performance of the water repellent. There has also been no further loss of material, no additional accumulation of salts, and continued good adhesion of the hydraulic lime-based repair mortar.
